Ardmore Area Subwatershed Stormwater Retrofit Assessment

Hennepin County
Public Works
Environment and Energy

Prepared by Hakanson Anderson and Hennepin
County Department of Environment and Energy with
assistance from the Metro Conservation Districts

March 2016

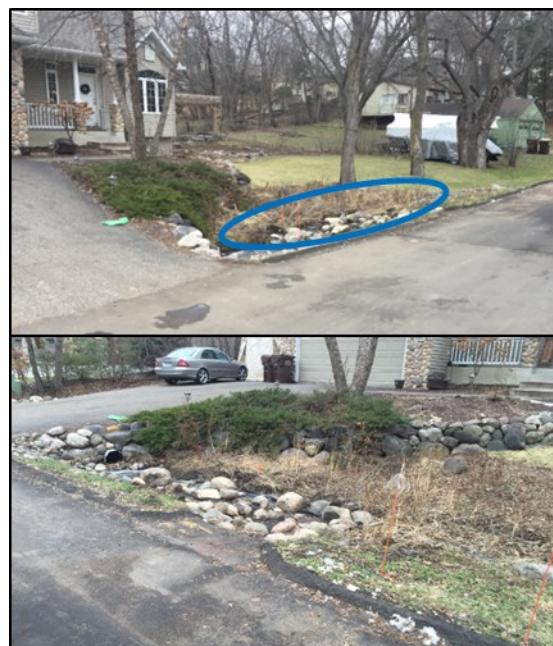
Figure 4U: Site photographs at proposed RG1

Two rain garden projects were chosen for this analysis. The first rain garden (RG1) is located on Walnut Street across from Walnut Park. It appears that a rain garden may have been previously attempted for this site; however, it does not appear to be functioning well and enhancements are proposed. There is an existing curb cut leading directly to the rain garden site, which can be seen in **Figure 4U**. In order to be effective, the rain garden must be over-excavated, filled with engineered media, and an underdrain installed. The final surface of the rain garden should be approximately 1.5' below the adjacent culvert to provide ponding during rain events. The phosphorus removal rate was estimated using the MIDS calculator. The projected phosphorus removal for RG1 is 1.1 lbs per year.

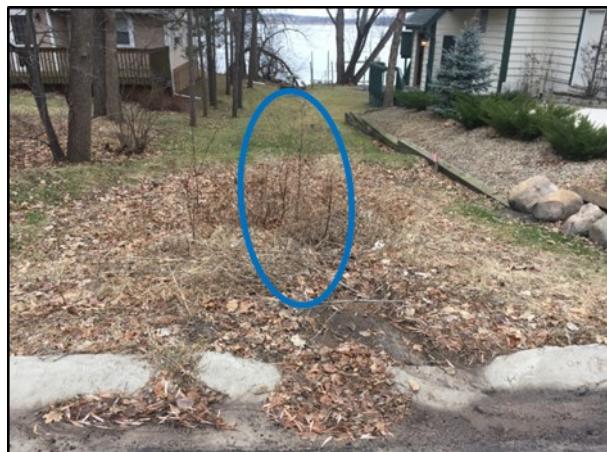
The second proposed rain garden (RG2) is on Lakeshore Avenue across from Brooke Street. There is already a rain garden on the east side of Lakeshore Avenue, but on the west side, the water is directed towards a curb cut that leads straight to Lake Independence (**Figure 6U**). A rain garden at this location could filter the runoff and decrease the phosphorus load before it enters the lake. The existing storm sewer pipe would be modified, with the rain garden intercepting and filtering the stormwater runoff. Suspended solids and particulate phosphorous would be trapped in the rain garden basin.

Figure 6U: Looking west to Lake Independence. The blue circle shows proposed location for RG2.

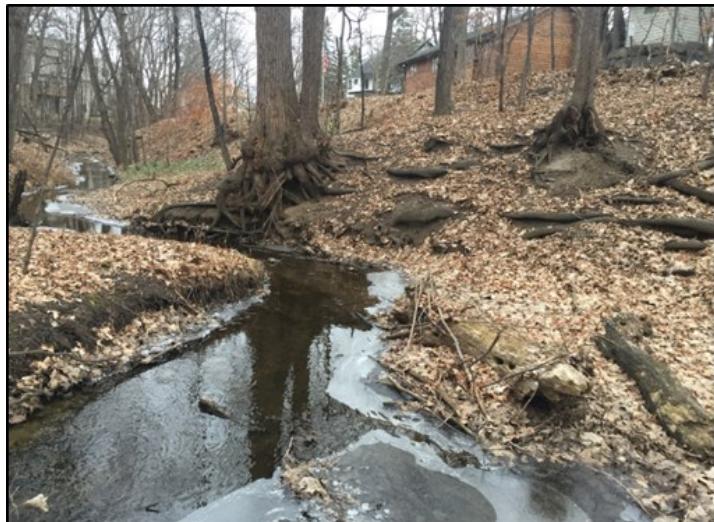
Figure 8U: Erosion seen looking southeast

We measured the volume of the moderate erosion to be approximately 40 cubic feet. The BWSR Pollution Reduction Estimator estimated 0.2 lbs/yr of phosphorus export from this area. Repairing the stream bank erosion would cease its TP loading. Repair and stabilization of this area may be accomplished by placement of toe boulders, brush bundles, or geo-synthetic mats. Native vegetation with deep root systems also helps stabilize these areas but may be difficult to establish in this location due to the extensive tree cover.

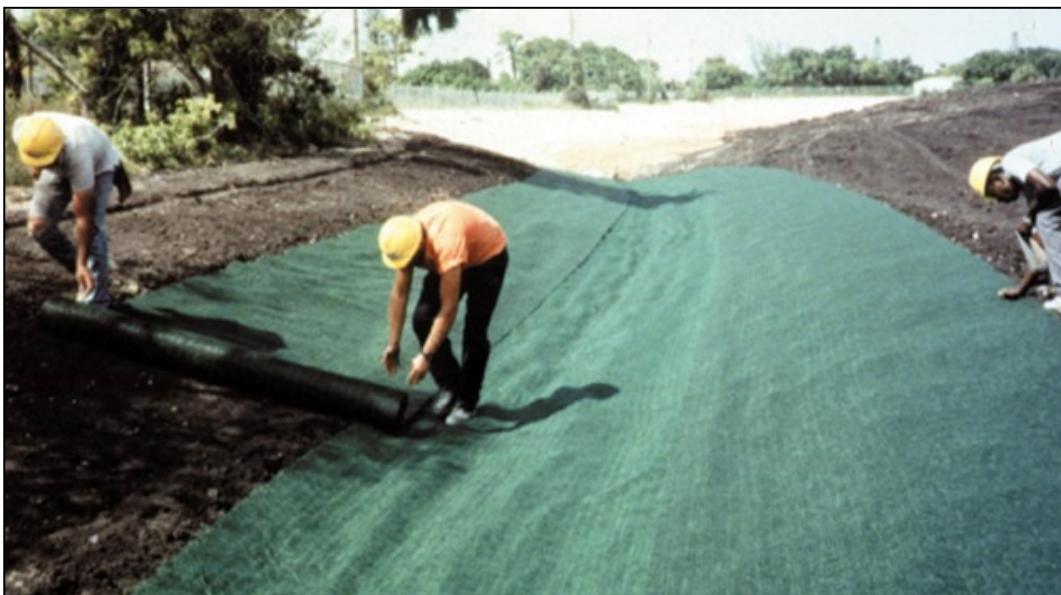
Figure 10U: Stabilization using manufactured synthetic products; Source: Contech Engineered Solutions

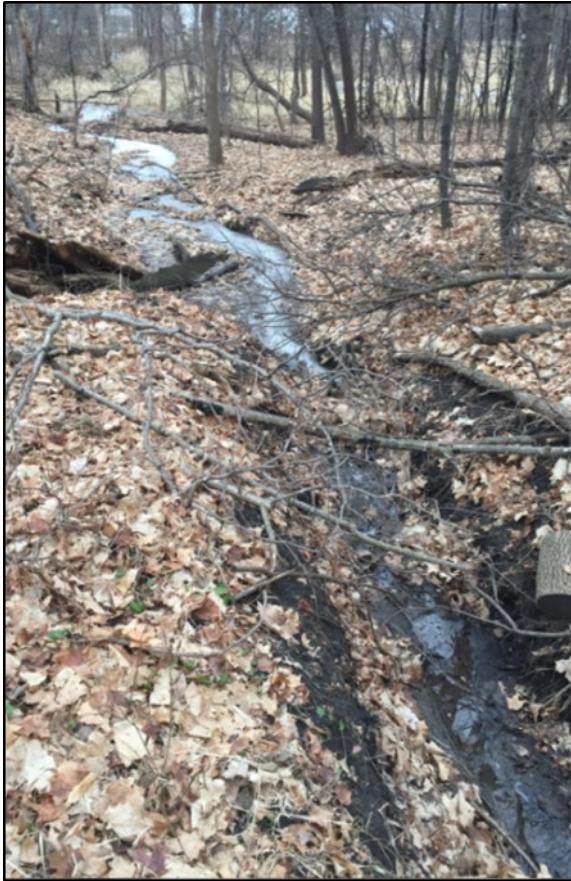
The gully north of Fern Street receives concentrated flow via a storm sewer pipe. Field measurements showed that the gully is approximately 120 feet long. The largest width measurement was recorded as five-feet, and the largest depth measurement was recorded as four-feet. In total, it is estimated that 1,390 cubic feet or 50 tons of sediment has been eroded to date. The BWSR Pollution Reduction Estimator worksheet was utilized to estimate the phosphorous load that the gully is producing. Stabilizing the gully could reduce the TP load by 100%.

**Figure 11U: Left— Erosion to the eastern side of the gully. Right - West side of the gully, eventually flowing into wetland connected to Lake Independence.**

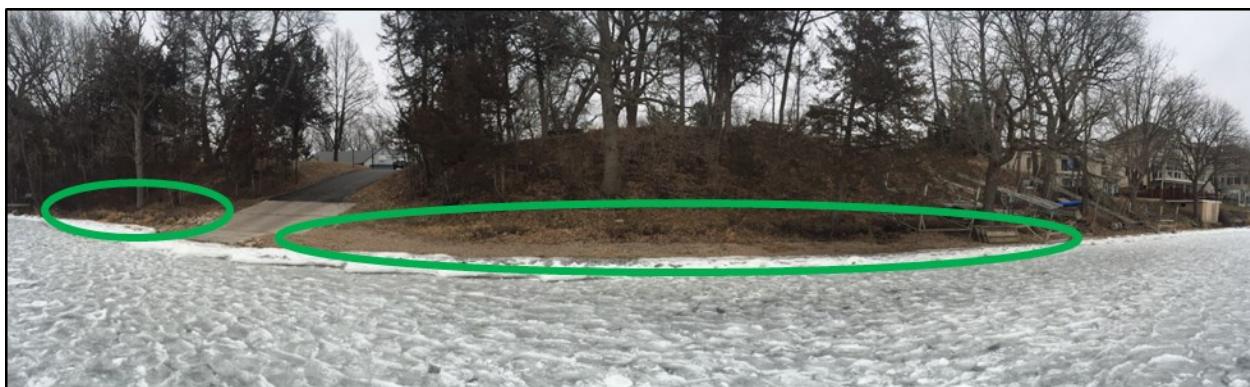
Figure 15U: The erosion exists on both sides of the boat launch. It extends approximately 120 ft. to the right of the launch and 40 ft. to the left.

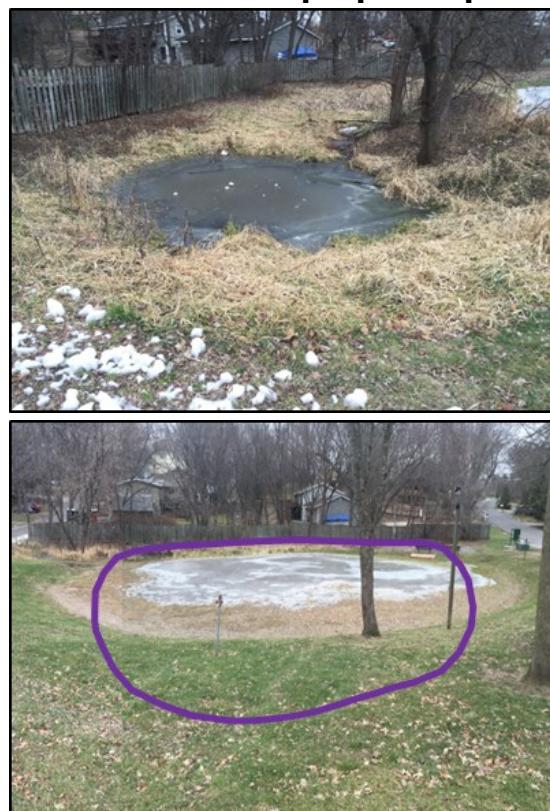
The first proposed pond to be excavated (PD1) is an already existing pond in Walnut Park. The current pond is estimated to have a surface area of 620 square feet and has a drainage area of 2.9 acres. This pond is severely undersized and is providing little treatment in the existing condition. To meet NURP standards, the pond must be enlarged considerably. It is noted that a rain garden is also proposed within this sub-watershed, which would remove a fraction of the suspended solids before entering the pond. Routing stormwater through multiple BMPs is often referred to as a treatment train and can have increased water quality benefits. The phosphorous reduction reported in **Table 9U** takes into account the minimal treatment that is occurring in the existing condition in the undersized pond.

Figure 18U: Top– The existing pond. Bottom– The purple line shows location of proposed pond.

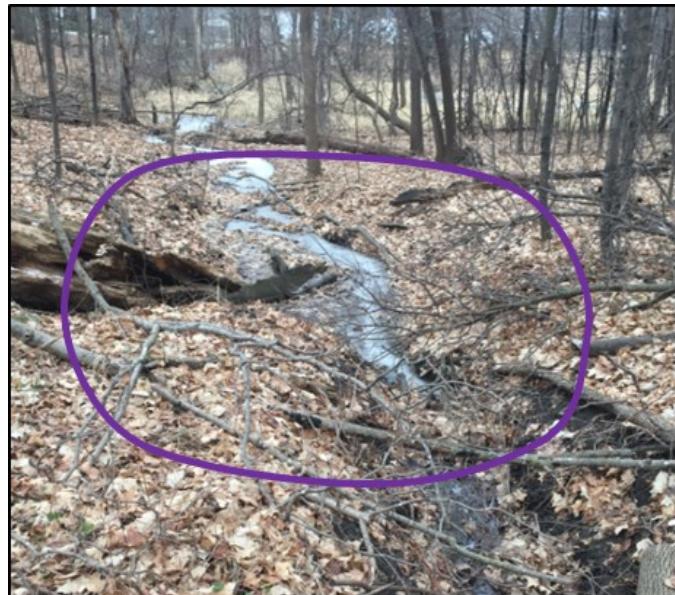
The second proposed pond (PD2) would be located at the receiving end of the eroding gully, north of Fern Street. This is a new proposed pond that would be approximately 2,900 square feet in surface area. This pond would have water quality benefits as it would intercept particulate phosphorous prior to discharging into the large downstream wetland, which is directly connected to Lake Independence. It should be noted that a gully stabilization project is proposed upstream of PD2, and it would be critical that the gully stabilization project be completed prior to implementing PD2.

Figure 20U: Purple outline below shows proposed location of PD2.

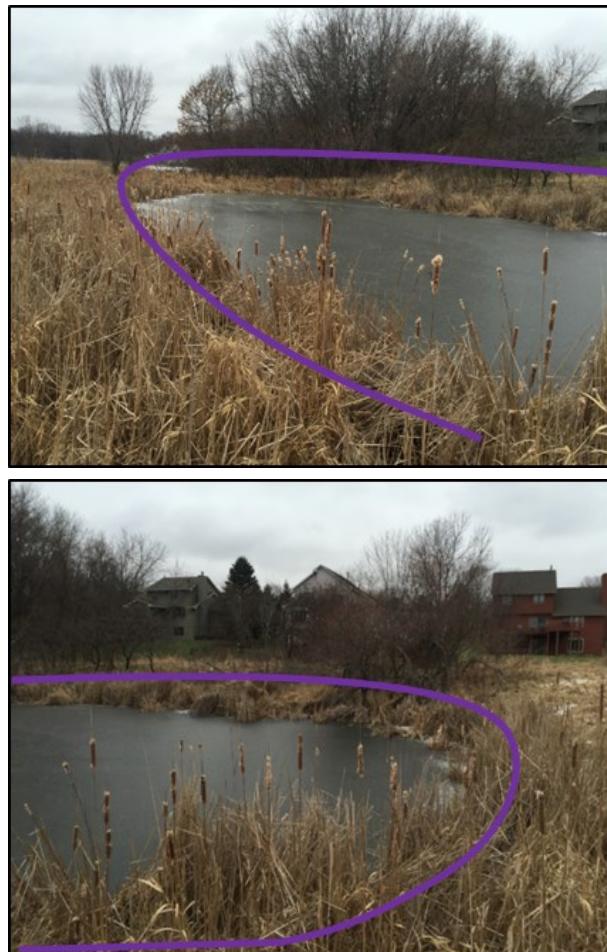
Table 11U. Site Summary – PD3	
Model Used	MIDS
Drainage Area	8.0 ac
Existing Pond Area	8,700 sq ft
Proposed Pond Area	14,000 sq ft
Estimated TP removal	1.1 lbs/yr
Installation Cost	\$31,800
Design/Admin	\$12,500
Maintenance Cost/yr	\$250
Total 30 Year Cost	\$51,550
\$/lb-TP removal /yr	\$1,562

Figure 22U: Purple outline shows proposed enlarged pond for PD3. Above- view looking south. Below- view looking west.

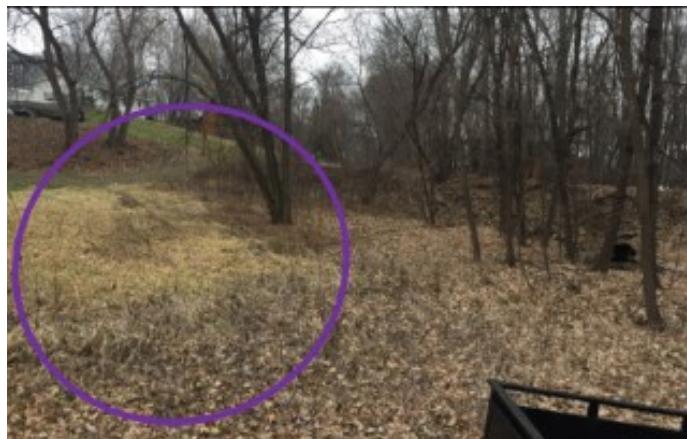
The fourth pond (PD4) would be a new pond west of the stream erosion. In the current condition, the storm sewer from Lakeshore Avenue directs stormwater into the vicinity of the proposed PD4, and it enters the stream untreated. A stormwater pond in this location would treat the stormwater and remove pollutants before discharging it into the stream and ultimately Lake Independence.

Figure 24U: Purple outline shows the proposed location of PD4. View is looking southwest.

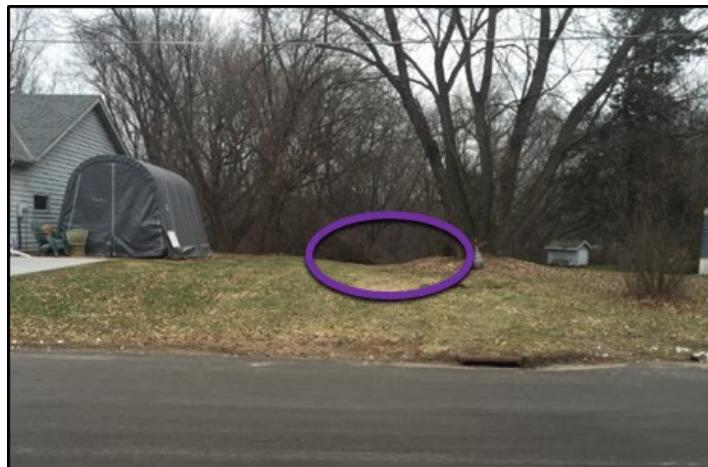
Figure 26U: Purple outline shows location of proposed PD5

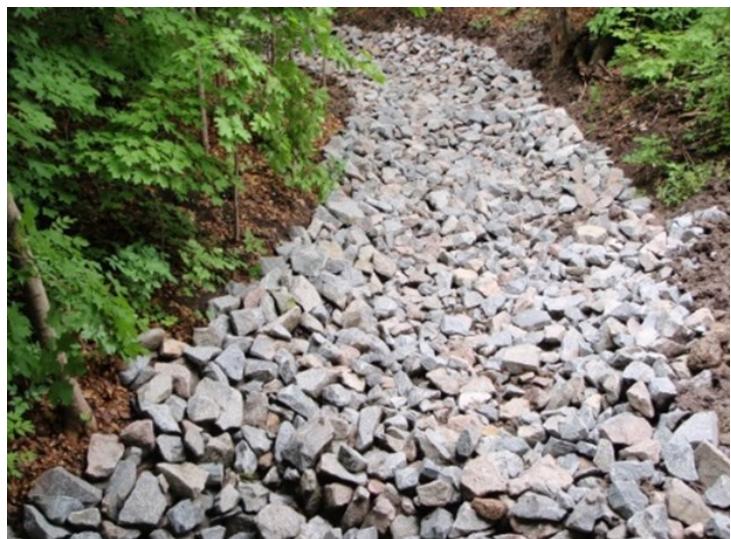
Figure 9R: Photo of rip-rap lined gully stabilization BMP

Stabilization of gullies typically requires reducing the volume and the velocity of water flowing through the gully. This can be achieved by refilling the gully and building dikes or small check dams at specific intervals along the gully. Reshaping and stabilizing long and steep banks may also be needed. Typical gully stabilization structures are constructed of rock, gabions or vegetative barriers. Biotechnical methods offer a combination of physical structures along with vegetative.

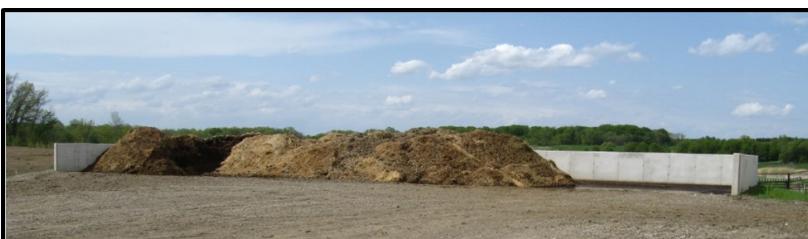
Figure 13R: Photo of aboveground concrete storage system for horse waste

For the two smaller facilities this report used composting as the primary practice to store and dispose of the horse waste and bedding. Livestock site B was designed as a smaller compost storage facility (2 bins 8'x8'x3' for 2 horses). Livestock site C was designed with a larger compost facility (4 bins 8'x8'x3' for 6 horses).
